Report 2405

**An Historic Building Recording Survey at
Ivy Farm, Stanhoe, Norfolk**

ENF125176

December 2010

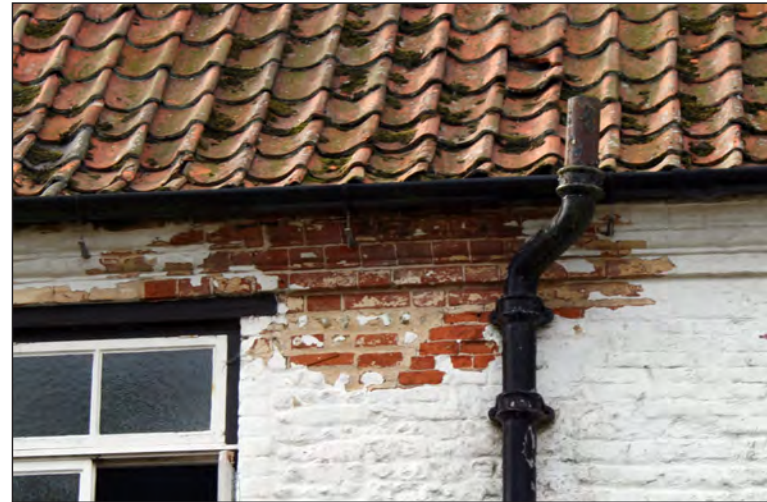
Plate 2. Moulded brick cornice on Building A north elevation

Building A was rectangular in design with a length of 17.35m and width of 6.68m (Figs 2 and 3). It had a red pan tile roof gabled to the east and west each surmounted by a red brick chimney (Plate 1). A third brick chimney rose from the ridge line approximately 5m to the east of the western gable end. All four external walls had been coated in white paint with a contrasting shallow plinth approximately 0.4m high and painted black extending around the base of each side. At the eaves to the north and south a moulded brick cornice had been applied in four courses using a much finer brick than that used elsewhere on the building (Plate2).

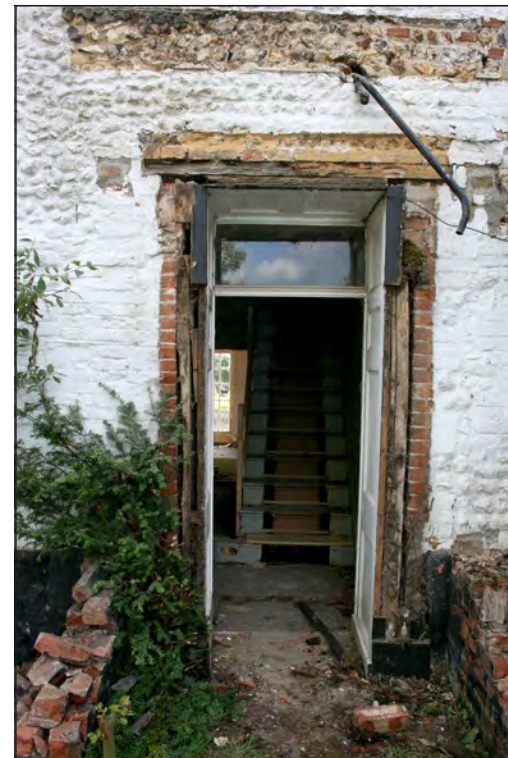
Plate 4. Front door with porch surround removed

The northern elevation constructed of coursed flint and brick constituted the main approach to the house and displayed four large rectangular windows evenly spaced across the façade's first floor giving the appearance of four distinct bays (Plate 3). The first and third windows (east to west) showed preserved sash windows of 10 over 10 lights, while the two remaining had been replaced with casements. Each window had brick jambs however those of the westernmost window differed slightly in character, and the opening was narrower than the other three perhaps suggesting an adaptation. On the ground floor a large canted bay window just to the west of centre must have dominated the elevation, although obscured by bushes at the time of the survey. It had a central sash of 8 over 8 lights with subsidiary sashes each side half this size. The front door stood to its east with traces of a removed porch visible upon the surrounding walls (Plate 4).

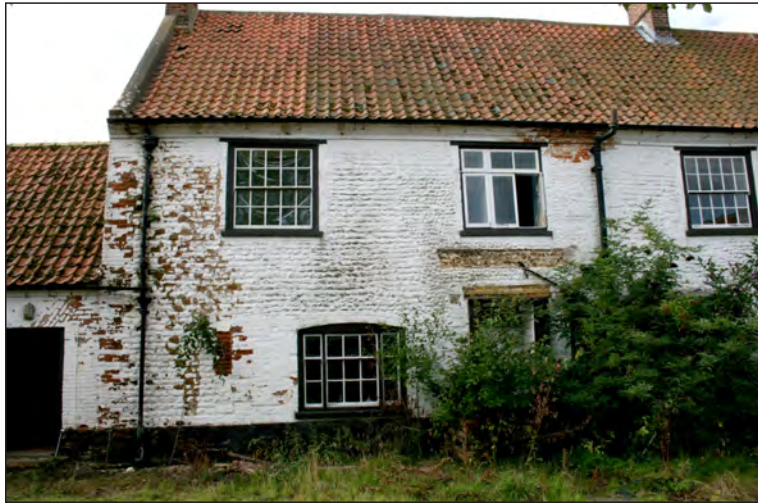
Plate 5. Relocated ground floor window on northern elevation of Building A

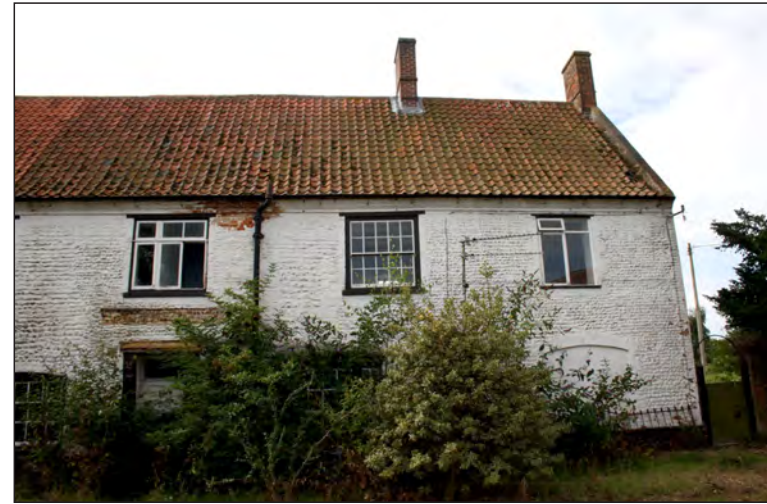
Plate 6. In-filled window on northern elevation of Building A

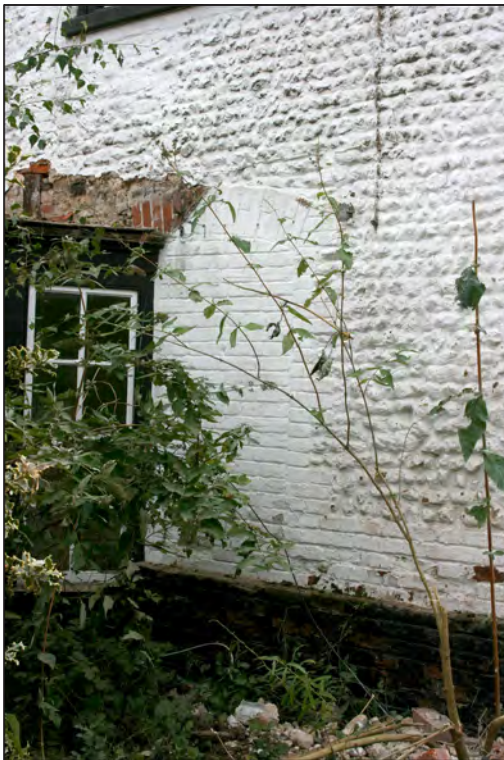
Between the front door and the bay window sat a small casement window, again obscured by foliage, while at the east end a large 3 over 6 sash beneath a shallow cambered arch appeared to have replaced an earlier opening further to the east that may originally have been more in line with that on the floor above (Plate 5). At the west end a second shallow cambered arch framed a similar opening but the use of brick varied from that to the east and the jambs had more in common with the window above. Unlike the cambered arch window to the east this opening had been in-filled and the in-fill rendered over (Plate 6). Inspection of the walling immediately to the west of the bay window suggested this feature had replaced an earlier opening as the remnants of a blocked cambered arch and western jamb similar to those seen to the west had survived the insertion and appeared to line up with the window on the floor above (Plate 7).

Plate 7. Blocked window beside bay window

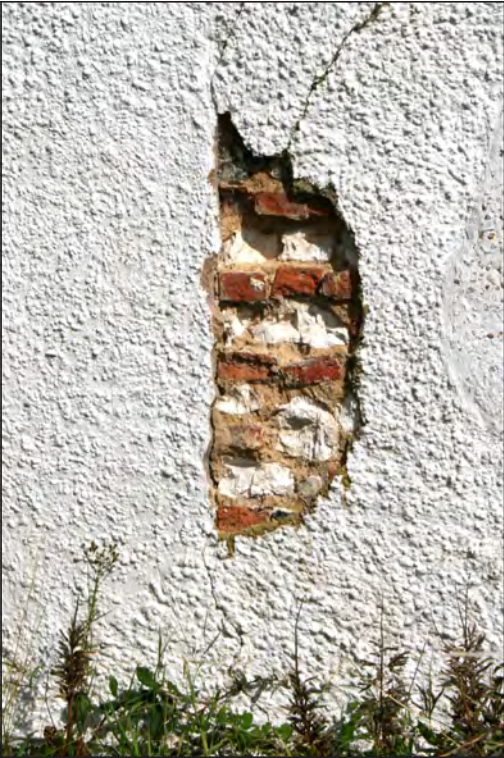
Plate 9. Exposed walling on west elevation of Building A

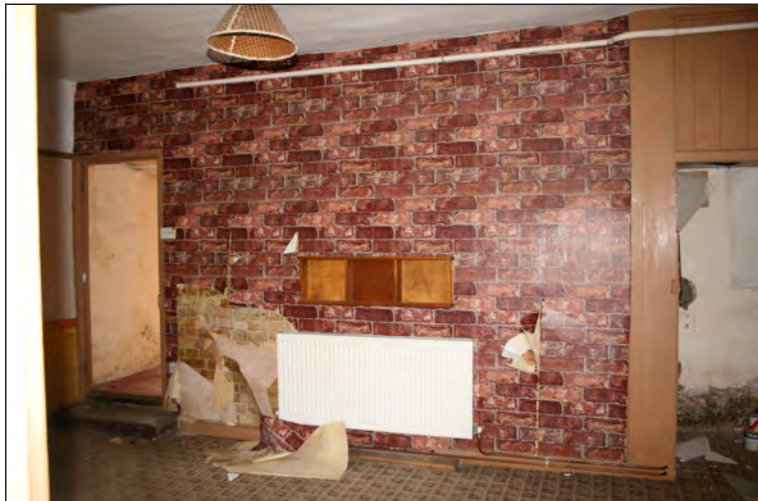
Plate 15. Boarded up fire-place in eastern ground floor room, Building A

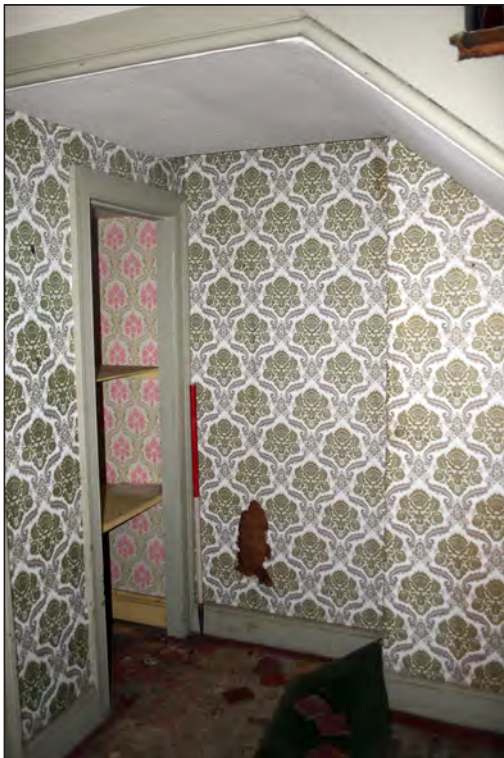
Plate 19. Blocked doorway beneath stairs
in Building A, 1m scale

It was clear that previously it had been possible, via a door in the west wall below the stairs to gain entry to the remainder of the ground floor of the house from the hall but this had been blocked up when the house was converted into two separate dwellings (Plate 19). Access to the ground floor on the western side of the building was granted by the doorway on the southern side of Building A, to the east of the rectangular bay window in the southern elevation. From here a large living room was located to the west with a fireplace against the centre of the western wall and bay window to the south (Plate 20). Along the northern wall an arched niche had been recessed into the centre of the blocked window visible from the exterior. Directly to the north of the southern doorway a second living space was present with a fireplace again set against the centre of the western wall (Plate 21). This room housed the bay window visible on the main elevation at the centre of the northern wall while a built in cupboard had been erected in the north-eastern corner. From the south-eastern corner of this room a staircase had been inserted (at the time of the division of the house) which led to the upper floor while the space beneath had been converted into a toilet with its entrance immediately to the east as you entered the house from the southern doorway. On the southern wall of Building A against which the staircase had been inserted it was possible to see the upper portions of what may have been originally an internal doorway leading into Building B (Plate 22). This too was likely blocked at the time of the partitioning of the house.

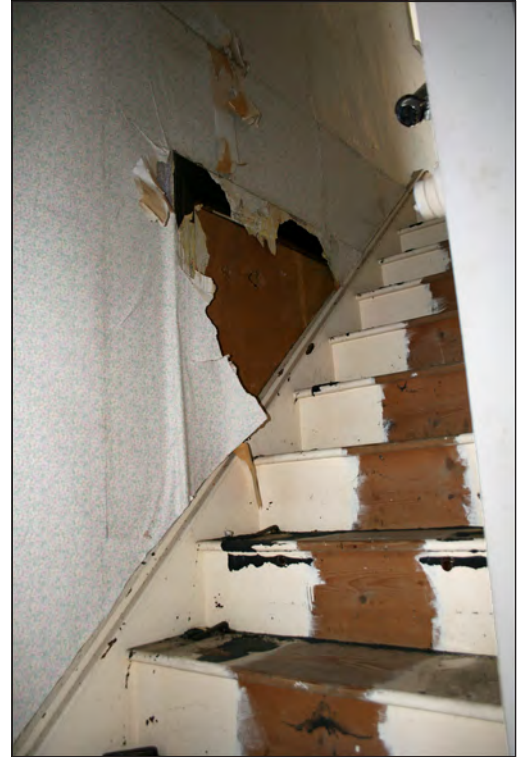
Plate 22. Blocked doorway formerly leading into Building B

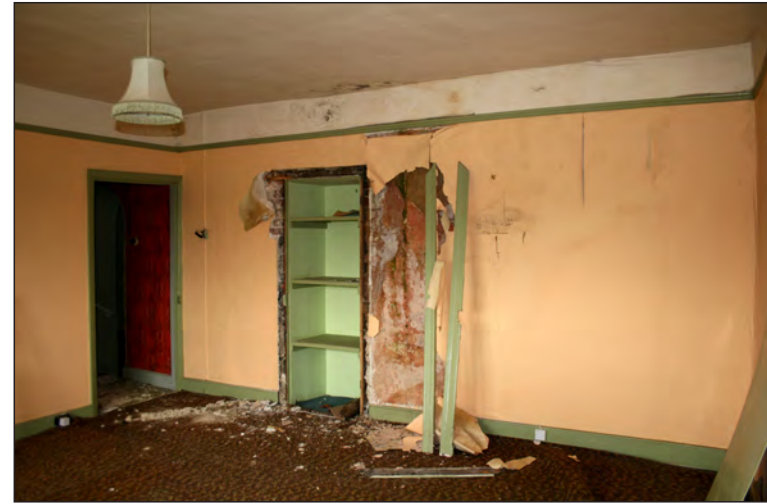
Plate 26. Niche indicating previous doorway in Building A

Buildings A and B (Plate 26). From the small landing turning east led up to the main landing corridor that ran north to south across the width of the house. From this corridor two rooms were accessible to the east both of similar dimension. The southernmost of the two served as a bathroom while that to the north appeared to be another bedroom. They were divided down the centre by an east-west cross-wall which intersected the chimney breast at the centre of the eastern wall.

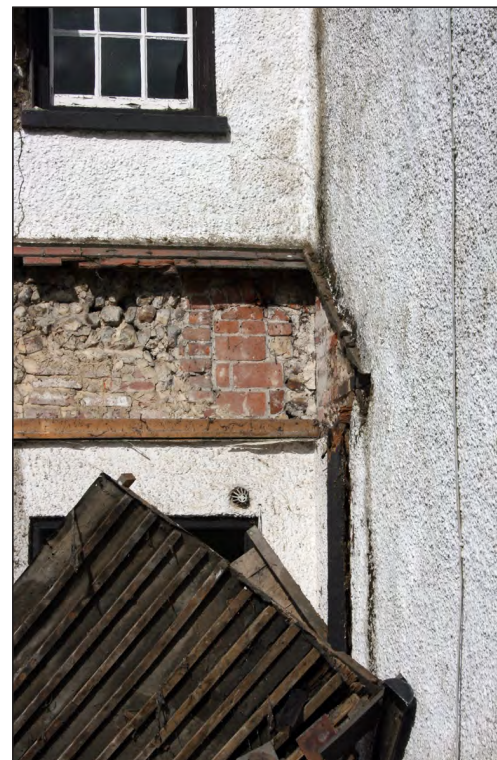
Several details came to light as a result of the demolition of the building that would otherwise not have been visible. Most obviously the construction methods used for the walls were recorded in cross section revealing the walls of Building A to be 0.65m thick at the base tapering gently to the wall plates (Plate 28). In contrast the walls of building B were 0.50m thick on the ground floor narrowing at first floor height by approximately 0.2m (Plate 29). Both buildings used chalk rubble and flint in a lime mortar with occasional bricks throughout and at the openings. Also of note was the identification of a small blocked window at first floor height on the southern elevation of Building A and partially obscured by the construction of Building B (Plate 30).

Plate 30. Blocked opening on southern elevation of Building A

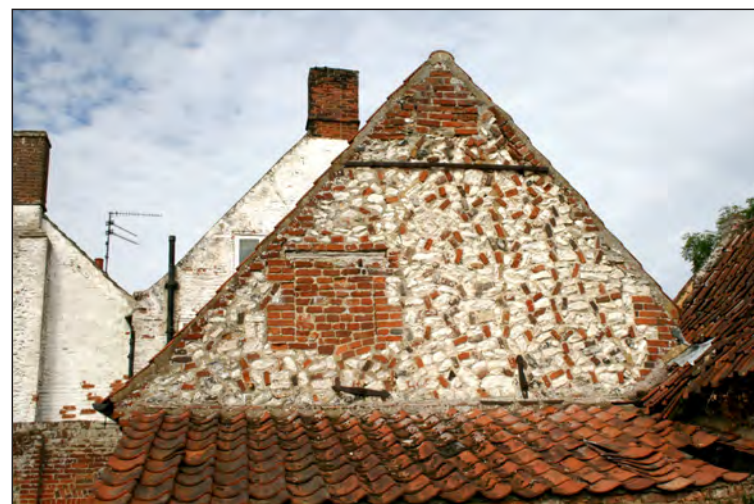
Plate 32. Eastern elevation of Building C

the southern end and below this and hidden from view by building E sat a doorway of similar construction and also blocked (Plate 32). Distinct from the remainder of the walling material the gable's apex was formed in coursed red brick and the presence of a chimney breast on the interior of this wall suggests this was the remains of a removed chimney stack. The southern elevation was similar in construction to the eastern gable with un-coursed brick and chalk however it was noted with interest that it also contained fragments of re-used Barnack stone (Plate 33), presumably quarried from a long demolished building of higher status in the local area. There were two doorways both of similar design located side by side at the western end of the elevation however a north-south garden wall to eaves height and located between the two divided the doors and presumably accounts for the need for both. The changing requirements of the building meant that the one to the west was no longer necessary and had been blocked up. From examination of the eastern face of the garden wall where it adjoined Building C it appeared there may have been a lean-to structure that had previously stood against the southern wall of Building C and was now only suggested by the survival of a possible roof line against the garden wall (Plate 33).

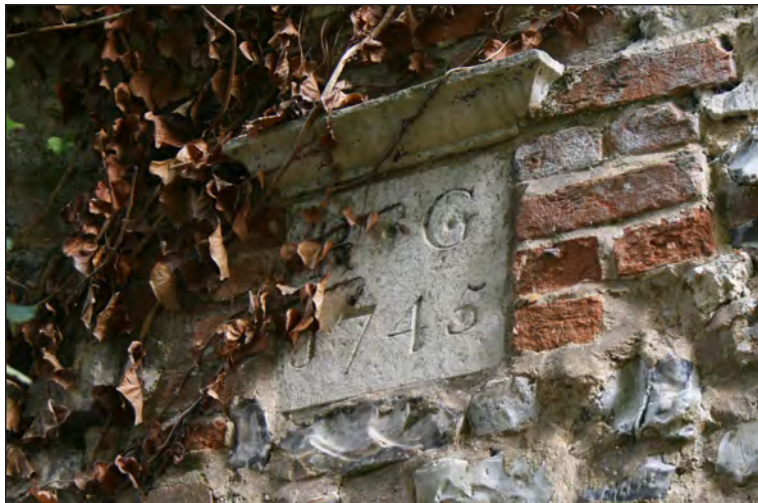
Plate 47. Date stone above blocked door on Building G

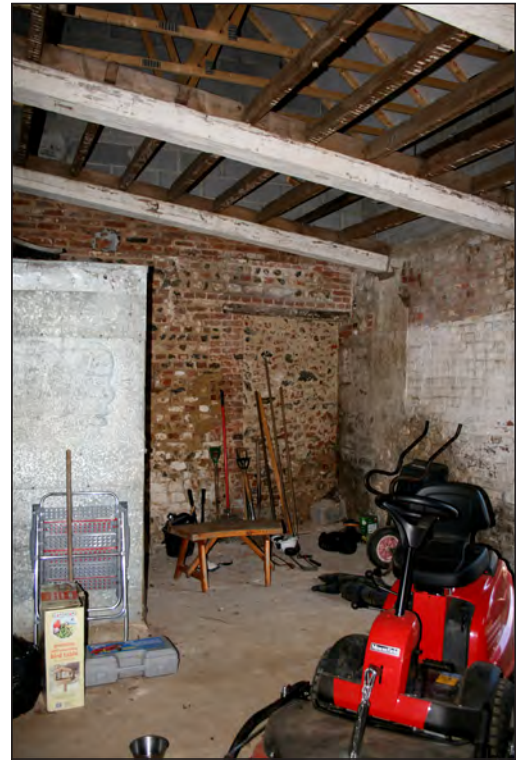
Plate 50. Blocked door in northern wall of northern cell, Building G
