Report 2405

**An Historic Building Recording Survey at
Ivy Farm, Stanhoe, Norfolk**

ENF125176

December 2010

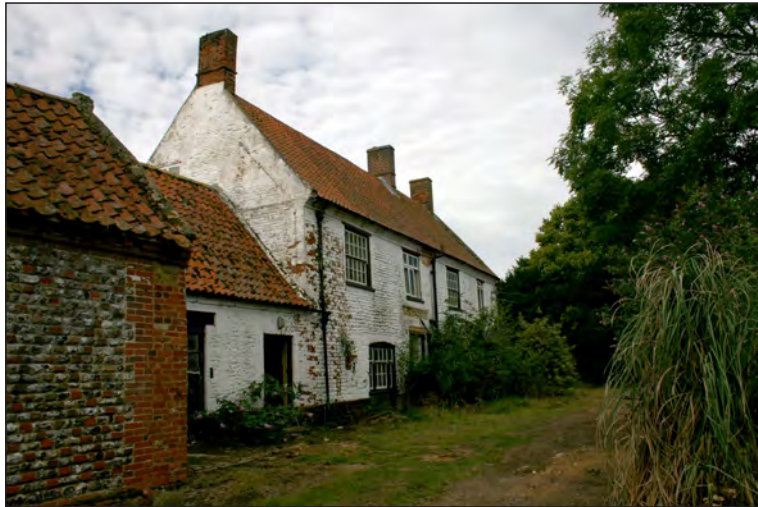
Plate 1. Building A, north elevation facing south-west

Building A was rectangular in design with a length of 17.35m and width of 6.68m (Figs 2 and 3). It had a red pan tile roof gabled to the east and west each surmounted by a red brick chimney (Plate 1). A third brick chimney rose from the ridge line approximately 5m to the east of the western gable end. All four external walls had been coated in white paint with a contrasting shallow plinth approximately 0.4m high and painted black extending around the base of each side. At the eaves to the north and south a moulded brick cornice had been applied in four courses using a much finer brick than that used elsewhere on the building (Plate2).

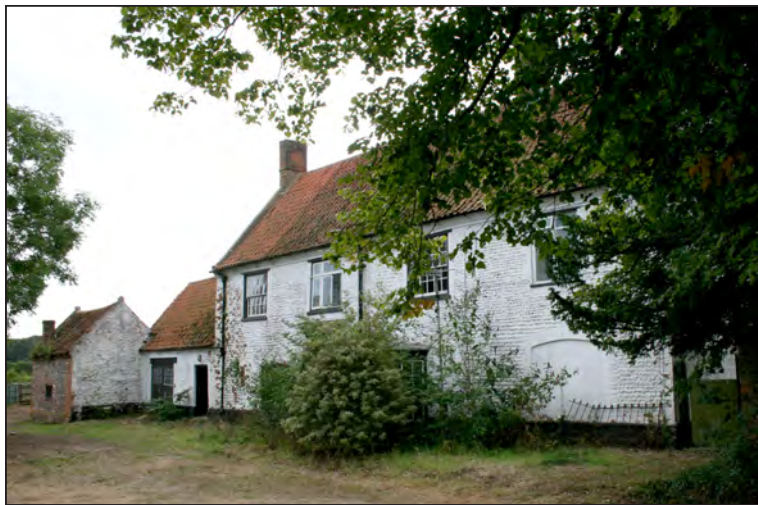
Plate 3. Building A north elevation facing south-east

The northern elevation constructed of coursed flint and brick constituted the main approach to the house and displayed four large rectangular windows evenly spaced across the façade's first floor giving the appearance of four distinct bays (Plate 3). The first and third windows (east to west) showed preserved sash windows of 10 over 10 lights, while the two remaining had been replaced with casements. Each window had brick jambs however those of the westernmost window differed slightly in character, and the opening was narrower than the other three perhaps suggesting an adaptation. On the ground floor a large canted bay window just to the west of centre must have dominated the elevation, although obscured by bushes at the time of the survey. It had a central sash of 8 over 8 lights with subsidiary sashes each side half this size. The front door stood to its east with traces of a removed porch visible upon the surrounding walls (Plate 4).

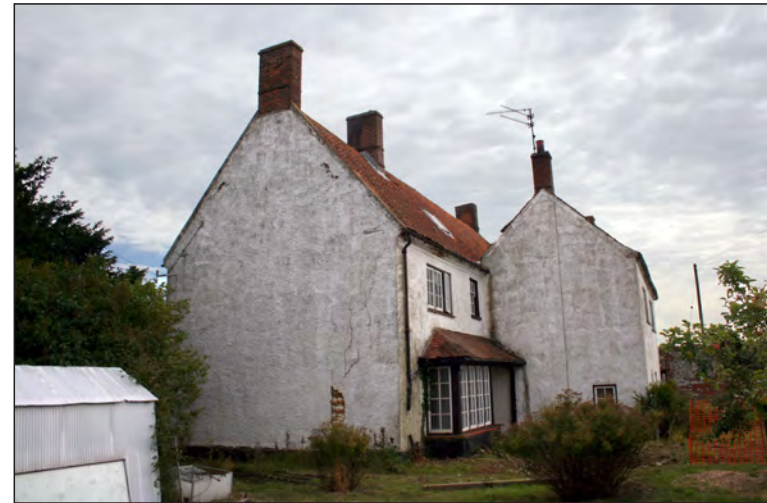
The western gable displayed no openings and a liberal application of pebble dashing prior to its coating in white paint obscured any evidence there might have been for such features. To the south a portion of render had fallen away revealing the wall's construction to be of alternating courses of brick and chalk in a lime mortar (Plates 8 and 9). In the gable above two opposing curved iron clamps evidently tied this wall back into the house.

Plate 8. West elevation, Buildings A and B

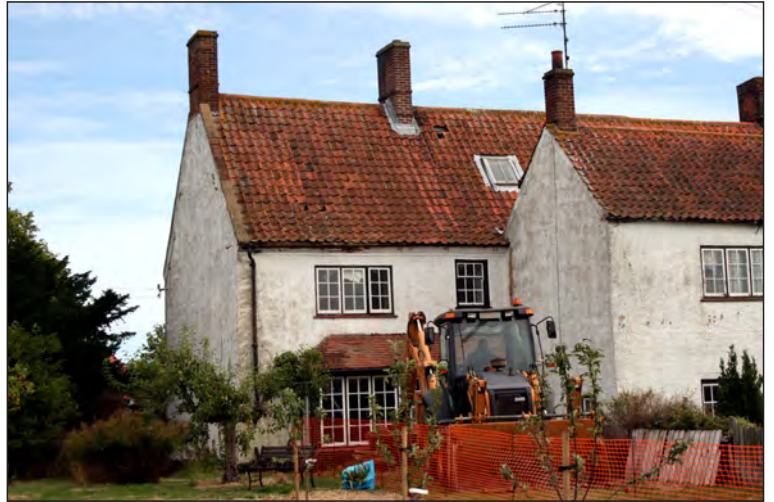
Plate 10. Southern elevation of Building A

design while above the bay window a more modern casement of three panels completed the fenestration (Plate 10). The eastern gable was again obscured by later buildings but externally the visible portions were of brick with a tumble-in pattern in the upper gable (Plate 11). By following the extent of this tumble-in design to the north it was clear that the pitch of the roof had been altered slightly. A clearly defined joint in the brick work indicated that the chimney stack above had evidently been widened. Both the first and second floors had rectangular modern casement windows to the south. Building C projected to the east under a gable roof.

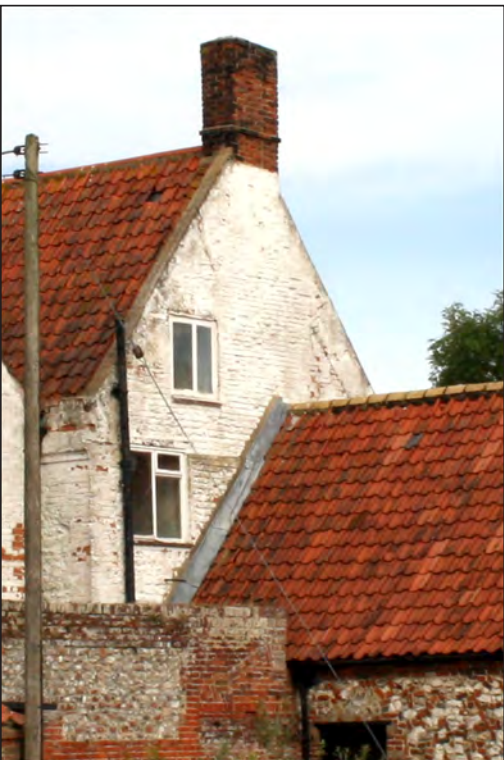
Plate 11. East gable of Building A showing tumble-in detail at eaves

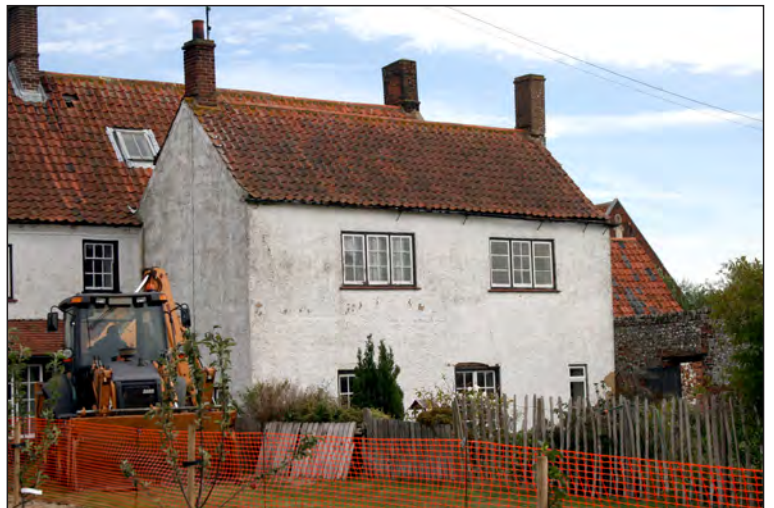
Plate 12. Southern elevation of Building B

Building B was a rectangular two storey extension appended to the eastern end of Building A's southern elevation (which served as its northern wall) (Figs 2 and 3, Plate 12). It measured 10m by 4.7m and to the south and west had received the same coating of white paint over pebble dash as Building A's west end. The elevation to the east was of red brick and flint but was also painted with a thick layer of white paint (Plate 13). The roof covering of red pan-tiles was flanked to the east and west by red brick chimney stacks rising from each gable end while to the north it adjoined the roof of Building A at the eaves to form a valley. The western elevation contained just a single casement window at the southern end of the ground floor which although still glazed had been blocked up internally (Plate 14). The southern elevation displayed two rectangular three-panel casement windows regularly spaced out across the first floor while two French windows on the ground floor below opened out into the garden with a third and smaller casement window at the eastern end (Plate 12). The eastern gable had a single modern casement window on the ground floor just to the north of a central chimney breast projecting away from the walls face and rising to the apex.

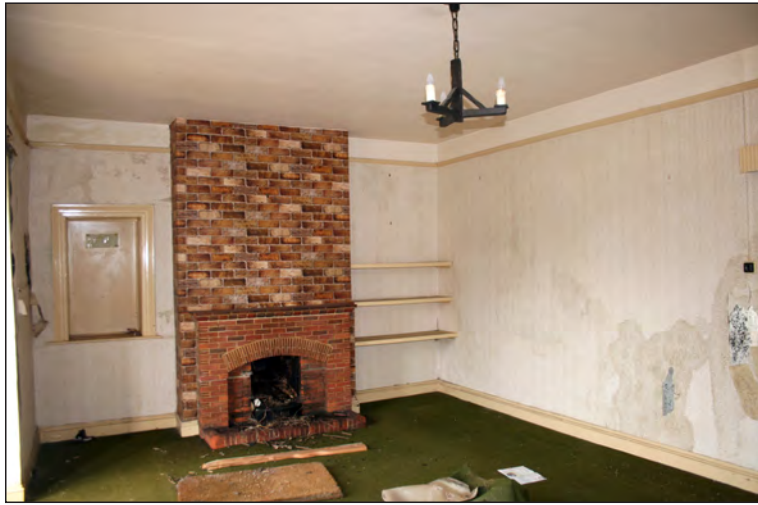
Plate 17. Ground floor, Building B, western room

From the southern end of the hall a doorway opened into a lounge room within Building B with a fireplace at the western end (Plate 17). Along its southern wall two sets of French doors opened out into the garden (Plate 18) while a niche on the western wall just to the south of the fireplace signalled the location of the blocked window visible from the exterior.

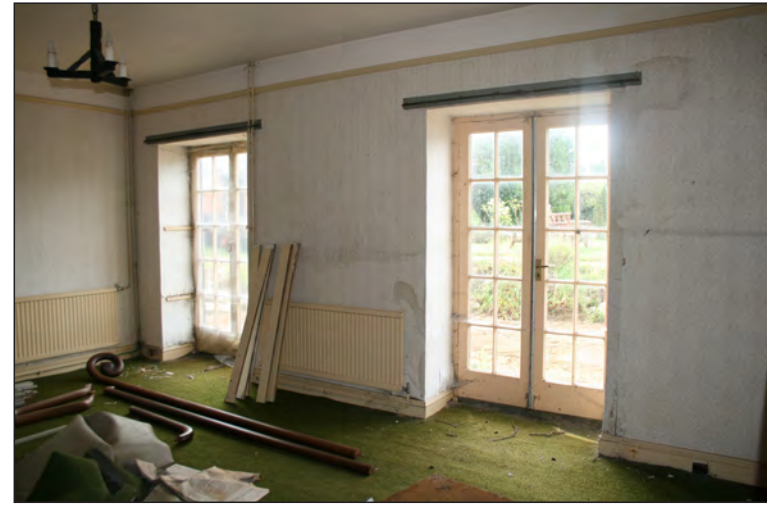
Plate 18. French windows, ground floor, Building B

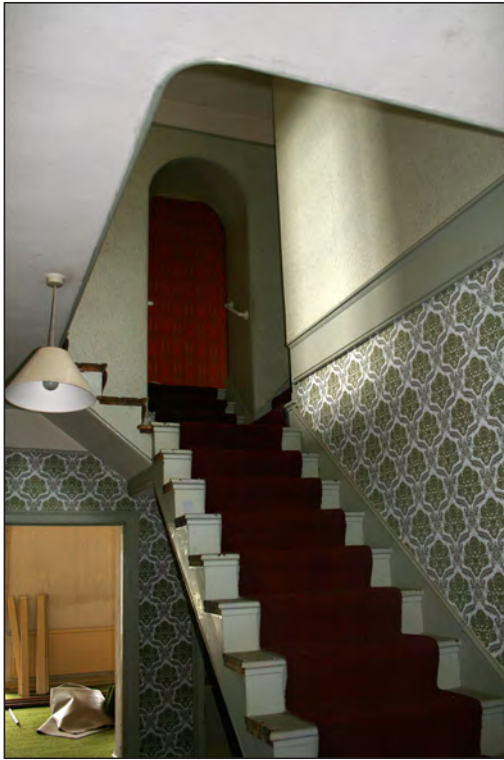
In the eastern half of the building the staircase led up to a small landing from which a further short step up led south into the first floor of Building B (Plate 25). Here two rooms of roughly equal size, one to the east and another to the west, were divided by a north-south partition wall. Each room had its own fireplace at the centre of its respective gable wall while the eastern room displayed a niche along its northern wall that indicated the previous location of a doorway between

Plate 25. Hall stairs leading up to first floor

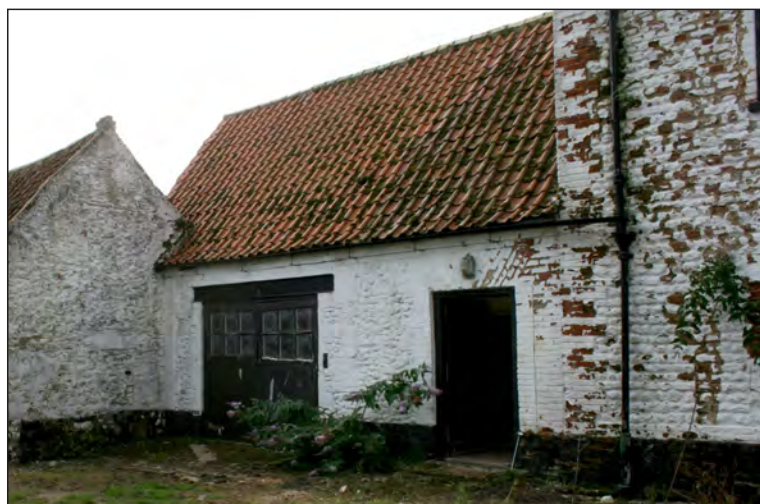
Building C was a single storey structure with roof space above that extended 8m east from the eastern wall of Building A which it relied upon structurally as its western wall (Figs 2 and 4, Plate 31). Its northern wall was aligned with that of Building A's northern elevation but with a width of 5.6m it was over one metre shorter to the south. A gabled red pan-tile roof extended across the length of the building where it formed a complex joint with the roof of Building D at its north-eastern corner. The northern elevation was constructed of roughly coursed flint and brick with brick dressings but had a thick layer of white paint applied across the whole face (Plate 31). There were two openings along this elevation, a double doorway to the east designed to admit a car and another to the west for foot traffic. The western jamb of the larger entrance indicated that perhaps some alteration had occurred in this area and the present opening might well have replaced an earlier window. The western entrance may well have been original and preserved at its head a square lintel formed in bricks set at a consistent 45 degree angle to leave a V at the centre (Plate 31). The eastern gable was partially obscured by building E however it had been constructed in a mixture of soft red brick and chalk with no attempt at coursing. An in-filled window with brick jambs was present at

Plate 31. Building C north elevation

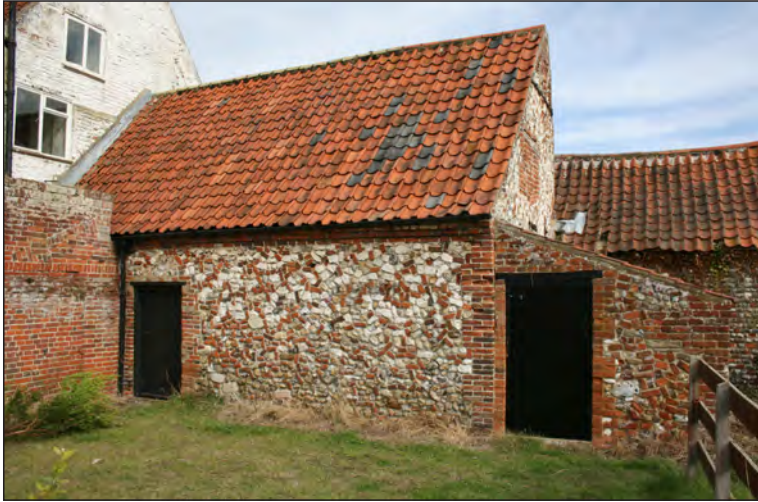
Plate 33. Southern elevation of Building C

the southern end and below this and hidden from view by building E sat a doorway of similar construction and also blocked (Plate 32). Distinct from the remainder of the walling material the gable's apex was formed in coursed red brick and the presence of a chimney breast on the interior of this wall suggests this was the remains of a removed chimney stack. The southern elevation was similar in construction to the eastern gable with un-coursed brick and chalk however it was noted with interest that it also contained fragments of re-used Barnack stone (Plate 33), presumably quarried from a long demolished building of higher status in the local area. There were two doorways both of similar design located side by side at the western end of the elevation however a north-south garden wall to eaves height and located between the two divided the doors and presumably accounts for the need for both. The changing requirements of the building meant that the one to the west was no longer necessary and had been blocked up. From examination of the eastern face of the garden wall where it adjoined Building C it appeared there may have been a lean-to structure that had previously stood against the southern wall of Building C and was now only suggested by the survival of a possible roof line against the garden wall (Plate 33).

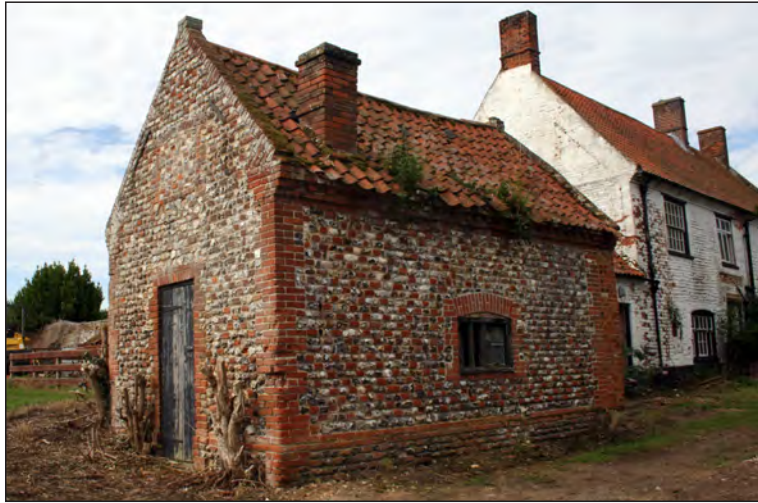
Building D measured 6.4m east-west by 3.9m north-south adjoining Building C to the north-east (Figs 2 and 4). It was constructed of a mixture of coursed flint and red brick headers with brick dressings and a gabled red pan-tile roof (Plate 37). To the north and south a brick dentil cornice sat below the eaves and to the north and east a shallow plinth ran across the base of the walls. At the centre of the northern elevation a low rectangular window with a cambered brick arch and internal

Plate 37. Building D facing south-west

wooden shutters provided the only natural light to the building but the eastern gable preserved the outline of an in-filled window in its upper gable (Plate 37). A doorway positioned directly beneath this latter window was the only remaining external entry to the building but in the opposing wall there were traces of another doorway with its threshold approximately 1.5m from the ground (Plate 38). This had also been in-filled and then heavily obscured by the application of white paint to the wall but nevertheless it was possible to see beneath this opening the truncated jambs of what might perhaps have been an earlier doorway at ground level. By examination of the north-western quoin it was evident there had been some rebuilding work at the western end of the building and it appeared that the structure had been lengthened by approximately 0.4m in this direction. As with Building A tumble-in brickwork had been used at both gables.

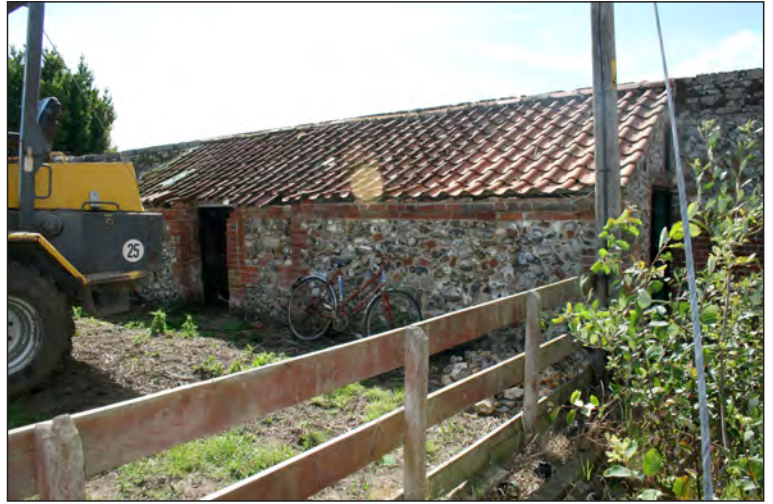
Built alongside the brick garden wall that extended south from the southern wall of Building C, Building F was a low lean-to structure 2.2m wide and 8.2m long with a red pan-tile roof (Figs 2 and 5, Plate 42). Its northern, southern and eastern walls were of flint rubble with brick headers with brick at the quoins and openings. In common with Building C it also contained fragments of re-used shelly limestone probably quarried originally at Barnack. The building was divided into three separate compartments, with a door in the northern wall allowing entry to the northern cell, a second doorway in the western wall giving access to an external central toilet cell and a third opening in the eastern wall leading into a wood store in the southern cell. To the north of the eastern doorway brick jambs may indicate a rectangular blocked window while above the northern doorway a small square opening remained (Plate 43). Traces of soot or coal dust on the walls and brick floor of the northernmost cell may have resulted from the storage of coal.

Plate 42. East elevation of Building F

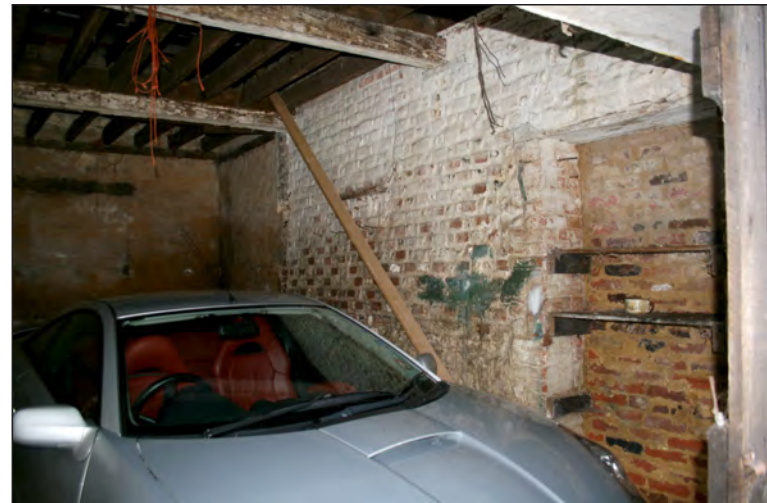
Plate 48. Southern cell of Building G

Building G had been divided internally into a southern cell and a northern cell by a red brick partition wall. The southern cell presently served as a garage (Plate 48) and the northern cell as a general storage (Plate 49) without internal access between the two, however a bricked up doorway at the eastern end of the cross-wall had previously allowed this function. The southern cell had whitewashed walls and a brick floor lain bedding face up while the northern cell had whitewashed walls to the east and west. The southern wall was plastered above 1.5m with black waterproof paint on the lower portion but the northern wall had been left without either. This wall divided off the already-converted remainder of the building but a blocked door at its eastern end indicated this had not always been the case (Plate 50). The floor was of concrete and a steel cell was located in the north-western corner.

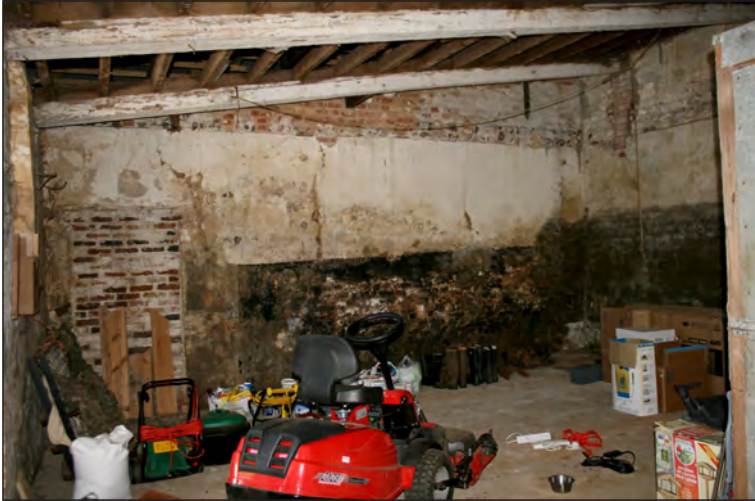
Plate 49. Interior of northern cell Building G

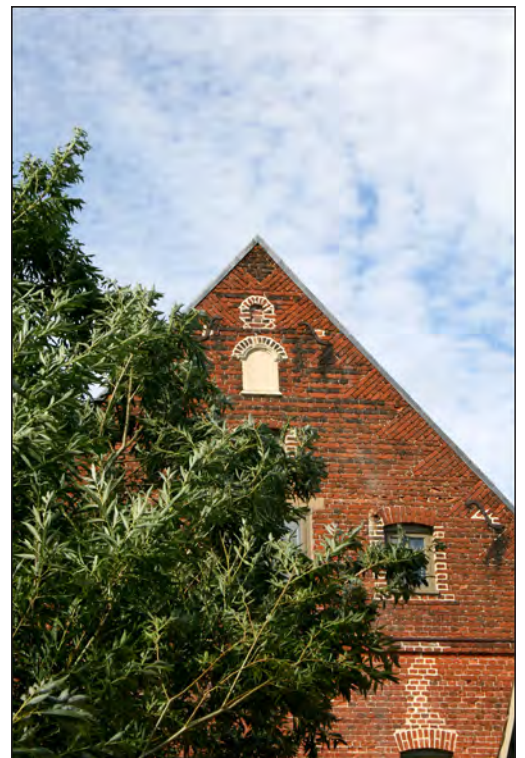
Plate 52. Ivy Farm barn southern elevation
